COMMONWEALTH OF KENTUCKY
DEPARTMENT OF HIGHWAYS
FRANKFORT

Interim Performance Report

MORTON'S GAP CULVERT-PIPE INSTALLATION

James H. Havens
Assistant Director of Research

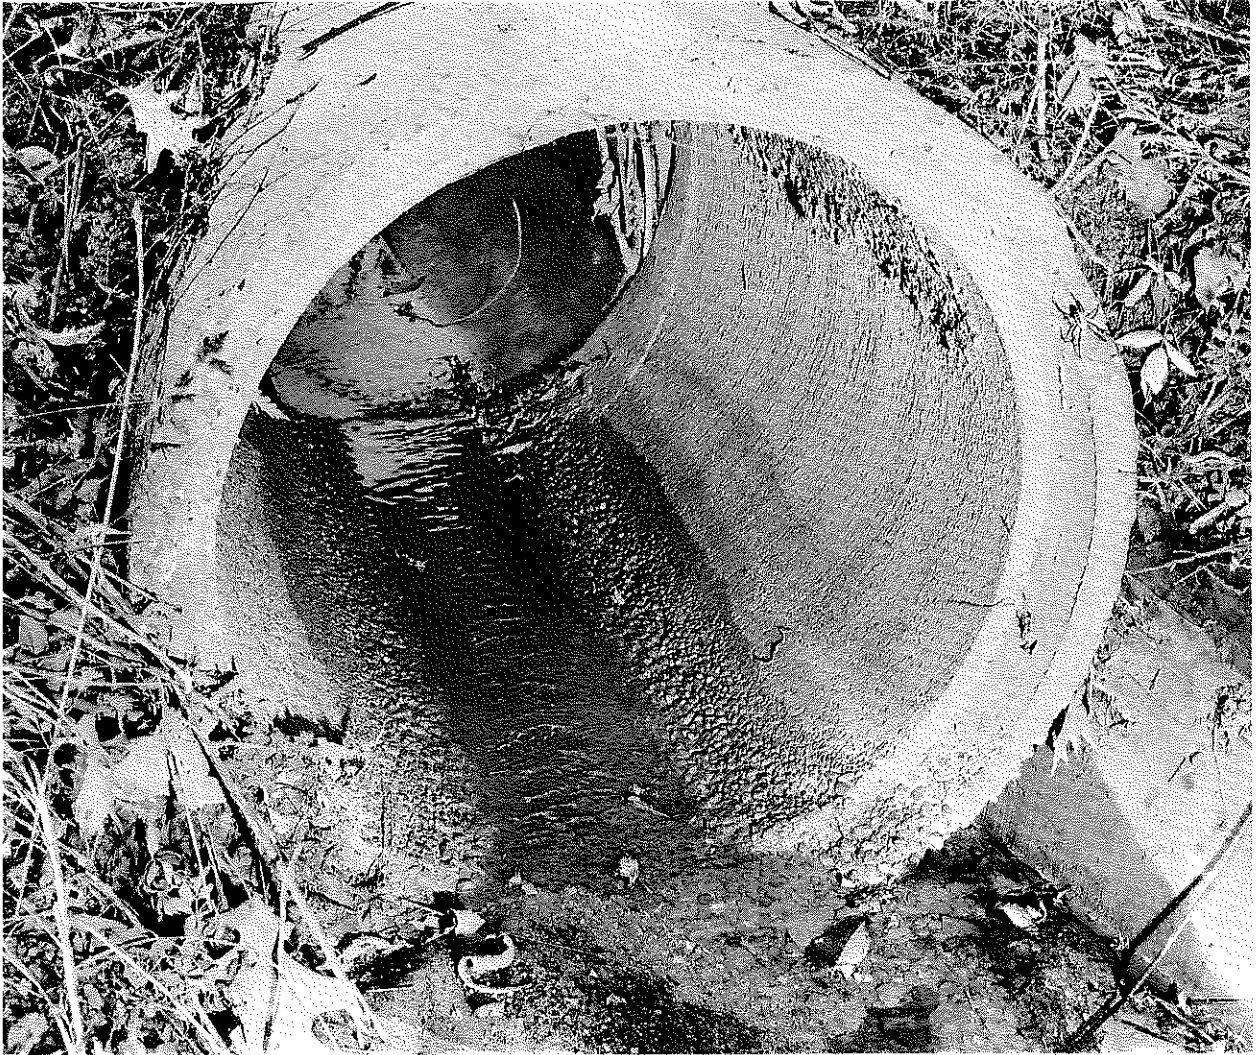
Concrete-River Gravel (2 Sections) - Installed April 25, 1951. Mortar along the flow line has been etched approximately 3/16 inch deep exposing the aggregate, by January 28, 1960 (see Fig. 2).

Fig. 2. Condition of Concrete Pipe Containing Siliceous Gravel Aggregate, as of July 21, 1959.

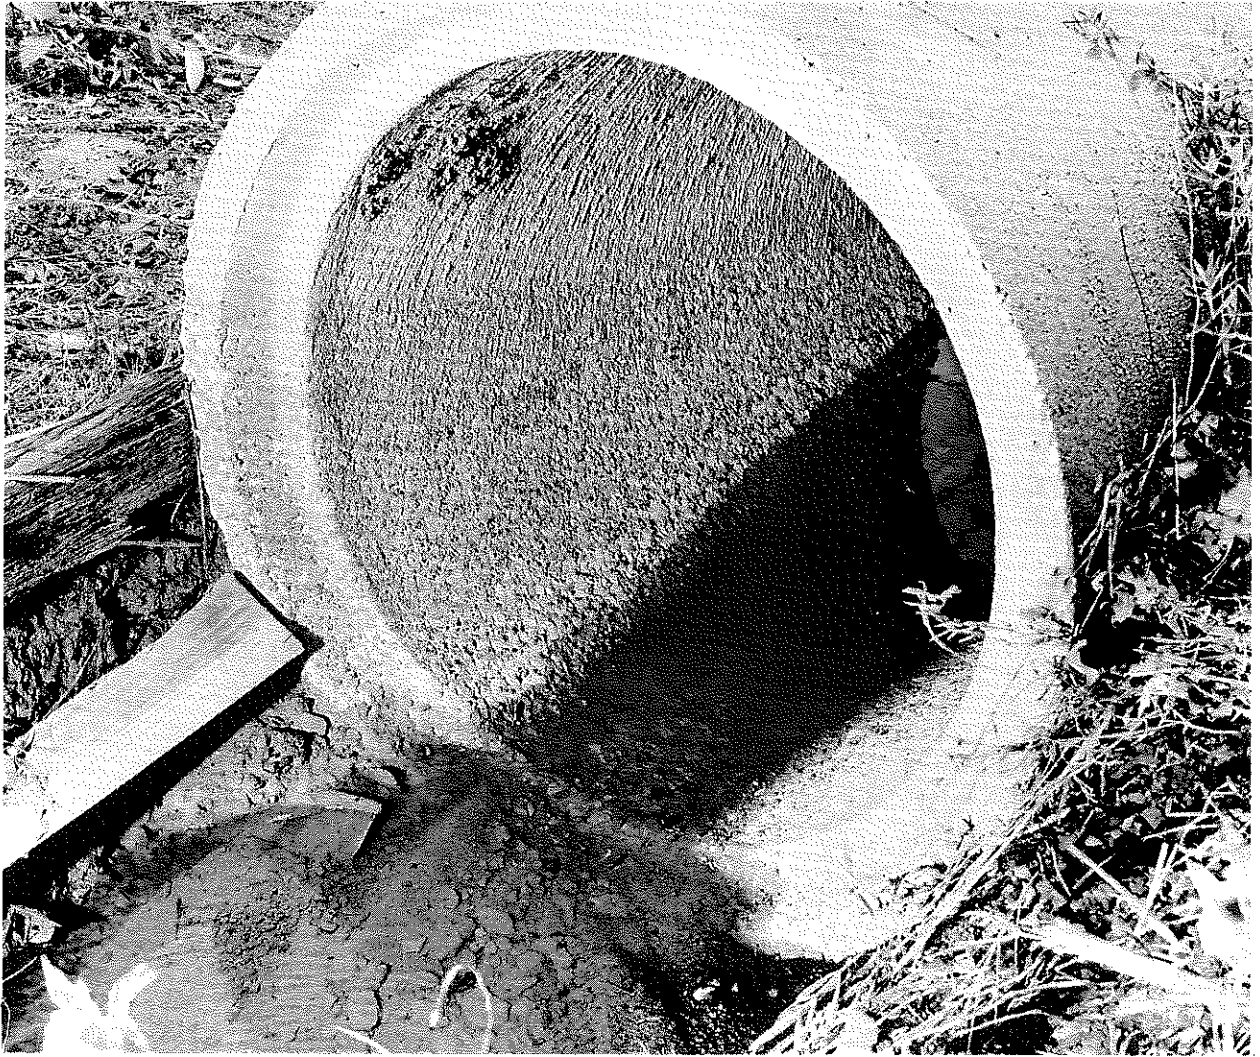
Concrete - Limestone Aggregate - Installed September 21, 1954. The mortar and aggregate have been etched out to a depth of approximately 1/16 inch or more, January 28, 1960 (see Fig. 3).

Fig. 3. Condition of Concrete Pipe Containing Limestone Aggregate, as of July 21, 1959.
